27 June 2008
Project 4630.01

Subject: Historical Review of Radiological Uses
Campus Bay Site
Richmond Southeast Shoreline Area
Richmond, California

- *Historical Review of Radiological Uses at the Campus Bay Site in Richmond, California*, dated April 2008, prepared by Alpha Beta Gamut (ABG) and Exponent, Inc..

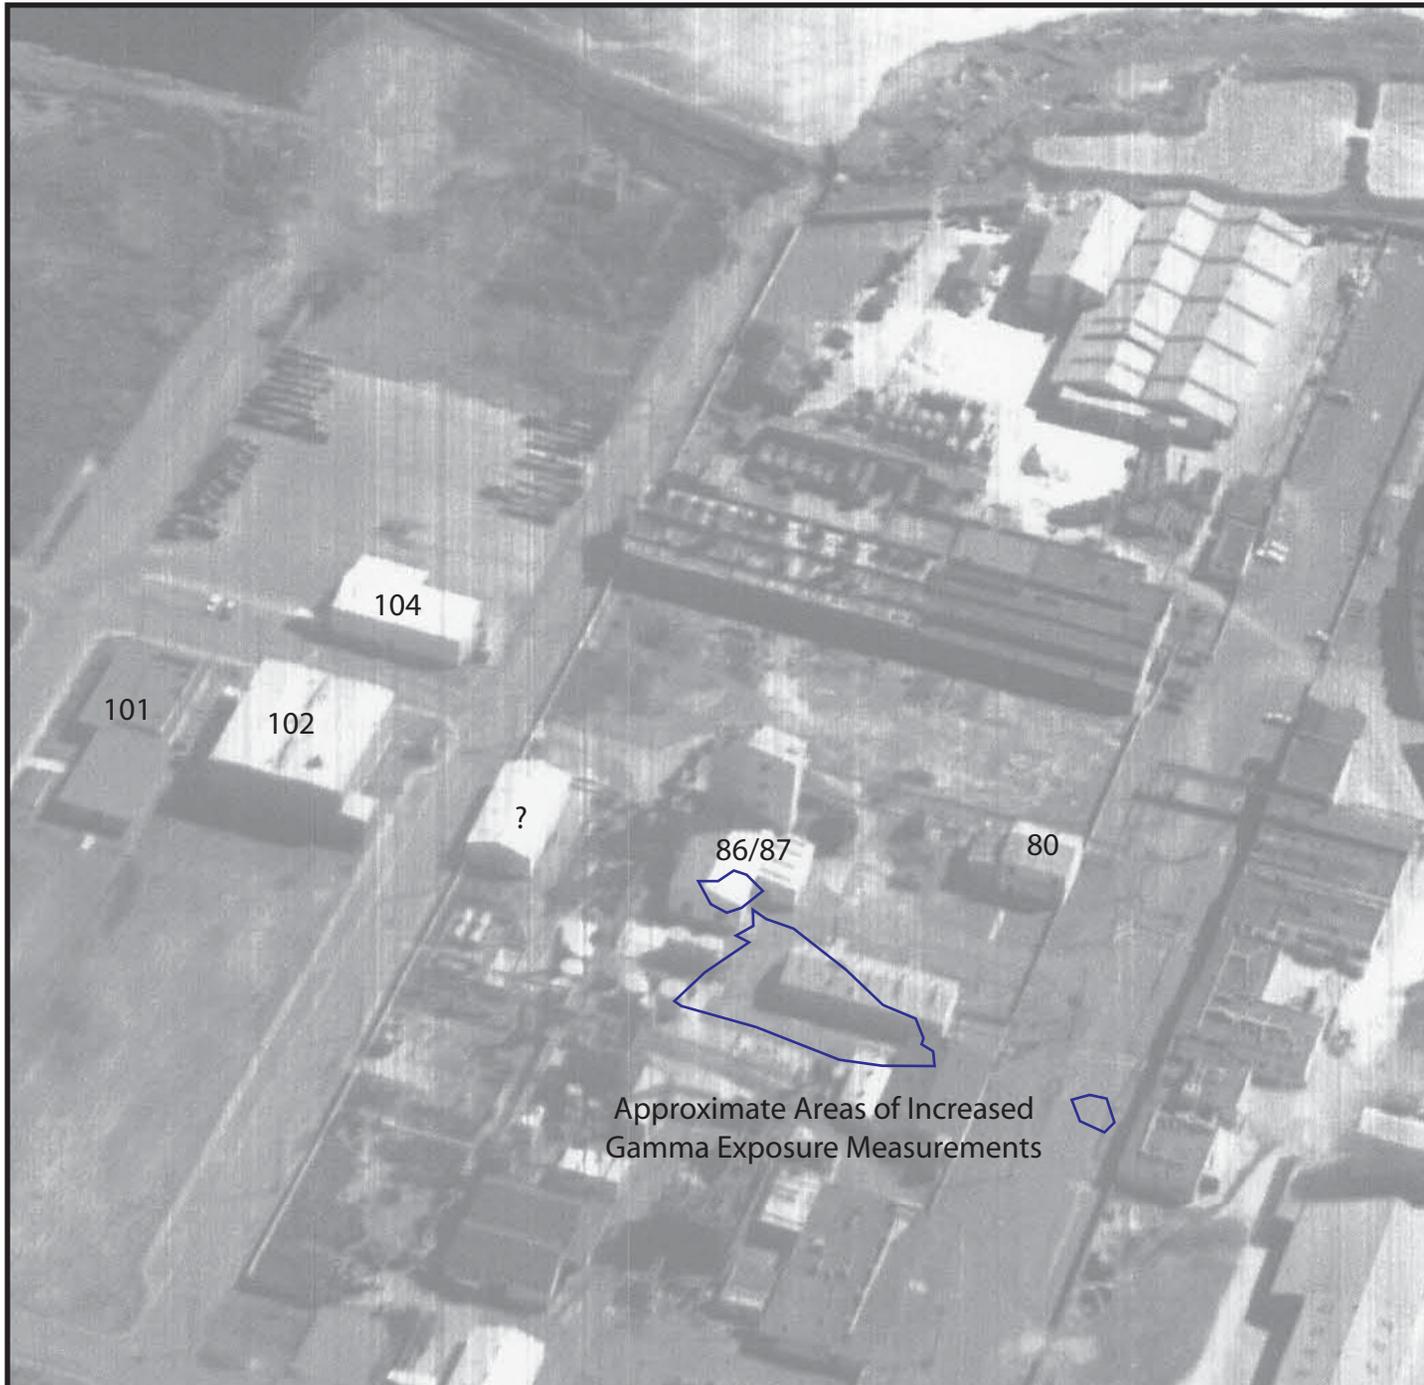
Undated Historical Aerial Photo Showing Building Numbers and Area of Increased Gamma Exposure

1. While the oblique aerial photo is undated, it was likely taken during the 1950s or 1960s.
2. The areas of increased gamma exposure measurements are not rigorously scaled (nor can they be against this photo) and should be considered approximate.
3. The areas of increased gamma exposure were identified as greater than surrounding site gamma scan results based on soil sampling performed by TetraTech on behalf of Zeneca, Inc. and Cherokee Simeon Ventures, I, LLC (TetraTech, 2008, Gamma Survey And Soil Sampling Results For The Zeneca/Former Stauffer Chemical Company Site , Figure 1-1).

Please provide more detail on the operations that took place at the Beryllium Laboratory or Former Building 80. The attached aerial photograph (looking south) was provided to the CAG by Bill Marsh of Edgcomb Law Group and is undated but appears to be from the 1950s to 1960s. Building 80 is noted and can be seen at the northeast corner of Seaport Avenue and South 47th Street. The taller Building 86/87 is on the north side of Seaport Avenue between South 47th and South 48th Streets and appears to be the same location as Building 86/87 on LFR's Figure 6 from the HRRU. Using LFR's Figure 6 from the HRRU and Figure 1-1 from the *Gamma Survey and Soil Sampling Results* by Tetra Tech dated 25 April 2008, we have labeled the known buildings near Building 80 or the Beryllium Laboratory and have also approximately located the Site area that had increased gamma scan levels. The higher-than-surrounding area gamma scan shadow appears to be covered by a lower building (brighter white) next to or adjoining taller Building 86/87. The higher-than-surrounding area scan shadow seems to be more closely aligned with Building 86/87 than Building 80. There are a number of other structures in the vicinity, including some large tanks that are not identified. The history on Buildings 86/87 indicates it was the tantalum processing pilot plant and that process is described in the HRRU. Given that ore was not processed, or at least there was no history of ore processing, it is unlikely that would be the source of high gamma background levels. What operations took place in the nearby unidentified buildings? Please provide complete operational histories and descriptions of each structure identifiable in the photograph.
